The Sewanee Coal Seam, Walden's Ridge and Development

ABSTRACT. The Middle Creek Watershed on Walden's Ridge in Hamilton County has a long history with coal mining. The Sewanee Coal seam contains 20 million tons of bituminous coal on Walden's Ridge, much of it exposed in the Middle Creek Watershed. Recently, the Town of Walden approved the creation of a strip center development located at the intersection of Taft Highway and Timesville Road. A strip center with 40,000 gallons of fuel storage is to be built at the top of the watershed over known mining activity, the coal seam and Acid Mine Drainage adjacent to and under the site. With no protection from zoning, regulations or responsible local government, the community is turning to TDEC to intervene with permitting and then regulation over this environmental disaster in the making.

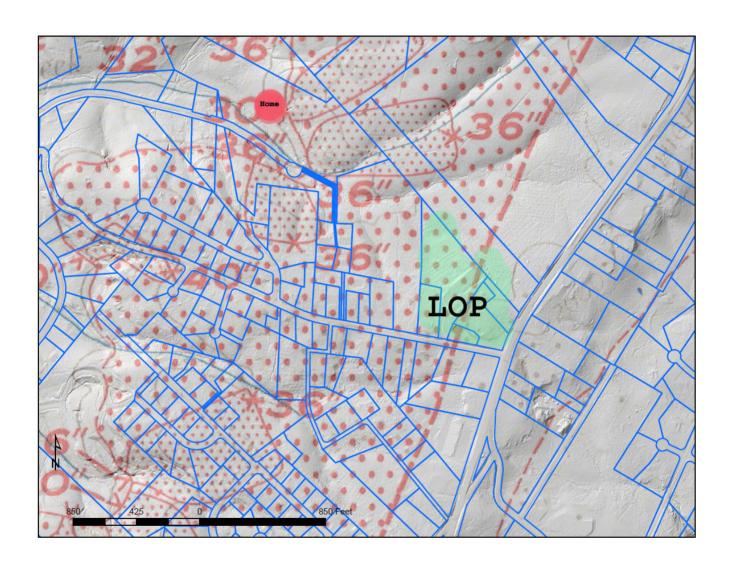
*Figure 8. Walden area parcels coal map Overlay of coal map on land parcels note.36" line of demarcation is mine thickness, not combustible coal.

Figure 4 shows a site diagram at 1823 Taft Highway of a proposed strip center, with this being the only information currently available for the project. The site is to include a 44,000 sq.ft. Grocery store and a fuel station which typically involves a fuel storage capacity of 40,000 gallons stored underground in this case involving steel tanks buried 10 feet under the pavement. The site preparation would involve removing close to 30 feet of mountain sandstone to accommodate fuel, sewage and storm water-management. All this over known mining activity with eroding chambers, interconnected mine cavities and millions of tons of coal. Figure 8, created by TDEC, overlays the lidar, properties and the coal seam map to clearly show the hazard that has drawn our concern.

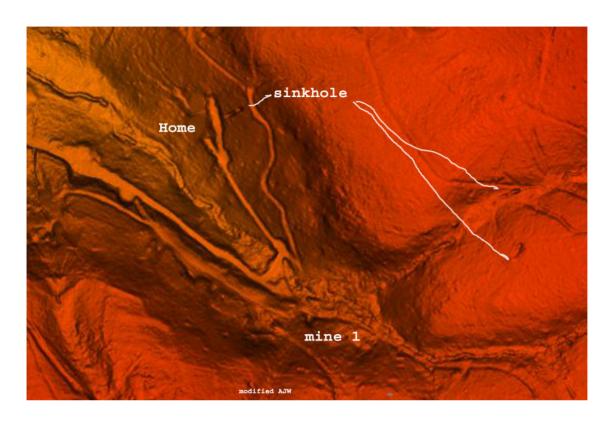
*Figure 9. Zoomlidar Lidar showing sinkholes from airshafts or mine entrances near LOP site.

The 1963 survey was conducted by interviews and local families state that the mining activity extended from my property to the other side of Taft Highway directly underneath the LOP site. The lidars provided by the State show 9 (Figure 10) active drainages in the watershed and a number of subsidences (Figure 9). Three subdivisions, multiple homes and the new high school are over the coal seam. Figure 7 shows the broader exposure of our community to coal mines.

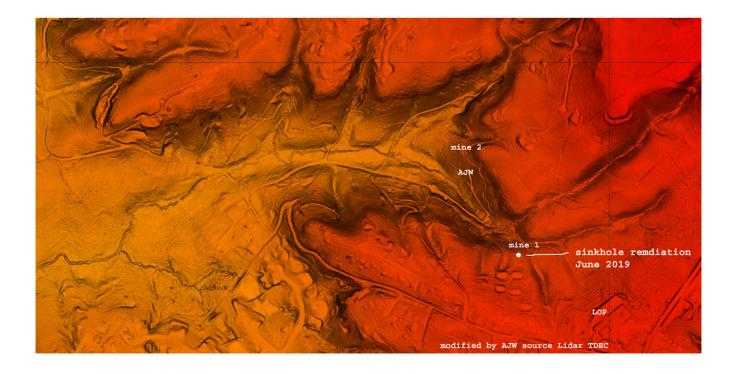
*Figure 10. <u>Active Acid Drainages</u> TDEC image with detail.

These 2 AMD sites on my property(mine 1) and 7 more in the immediate watershed(Figure 10) are all from the Sewanee Coal Seam. Both drainages on my property are continuous. Included(Figure 1) are signed records of the work and participants in this remediation effort and includes the LOP site as confirmed by the owners signatures to the 1990 reclamation projects and maps showing work on their properties.

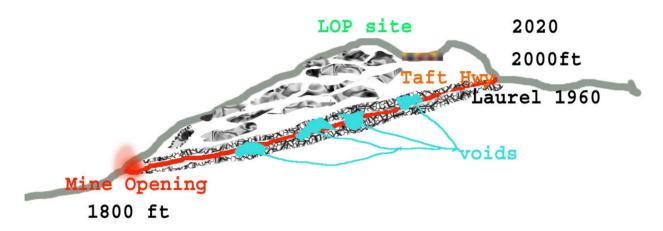
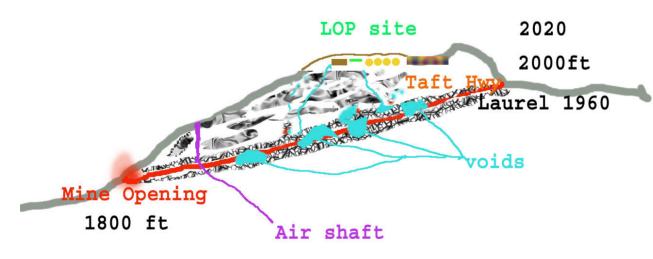
Figure 11. Possible geological profile A&B

With less than 50 ft of disturbed mountaintop (see Figure 11) over known mining activity, the possibility even probability that a subsidence would occur must be considered. The fuel tanks loaded with fuel and covered by pavement would be almost 500,000 lbs of additional weight on the site. A subsidence could
